REPORT OF INVESTIGATIONS/1989

Assessment of Experimental Longwall Recovery Rooms for Increasing Productivity and Expediting Equipment Removal Operations

Report of Investigations 9248

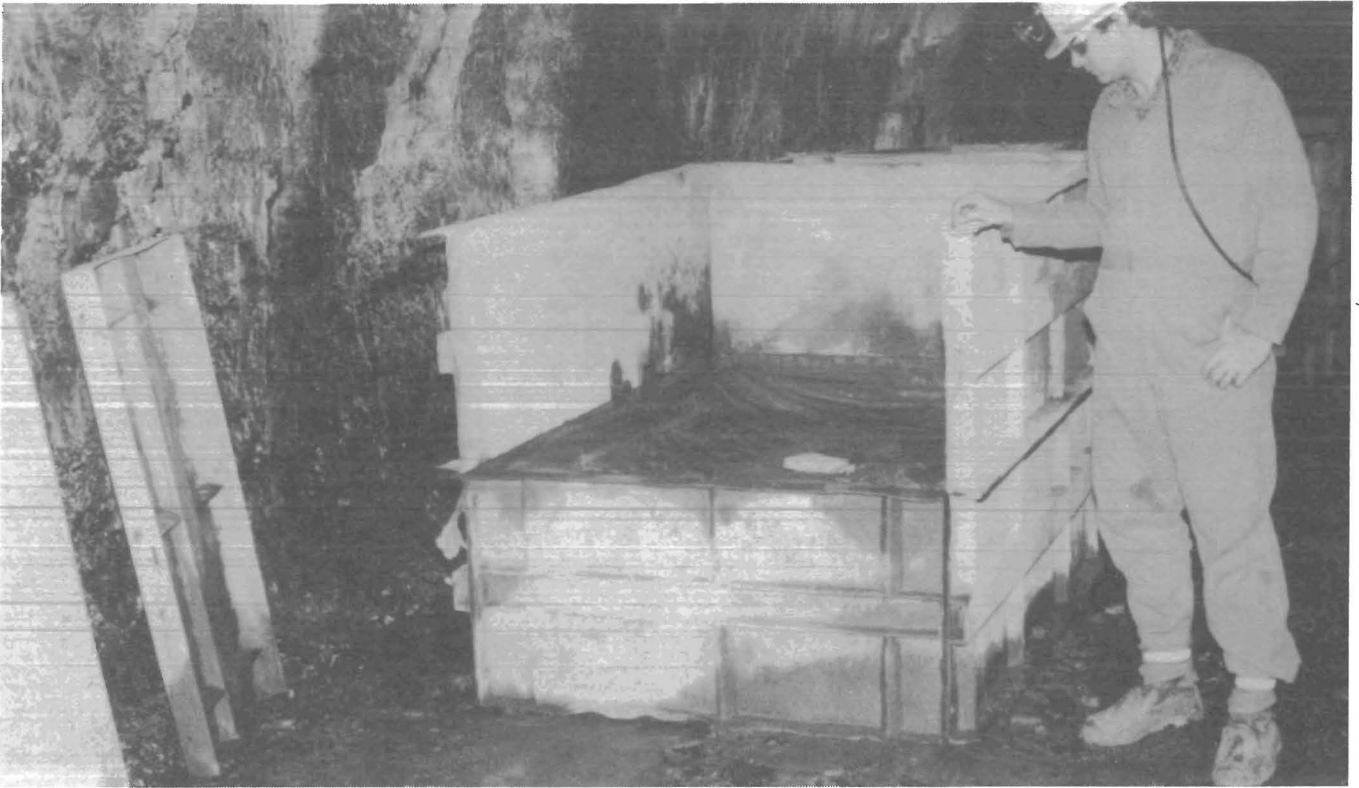
Figure 6.—First stage of constructing fly ash-cement piers.

A private contractor constructed the piers from a fly ash-cement material. The construction involved assembling 2-ft-high aluminum forms, lining the forms with burlap bags, then pumping the fly ash-cement into the bags (fig. 6). After the cement hardened, the process was repeated until the roof was reached. Bags made from mine brattice (plastic coated burlap) were pumped full of fly ash-cement, to fill any gaps between the piers and roof. For comparison, figure 7 shows a completed fly ash-cement pier next to a conventional wood crib.

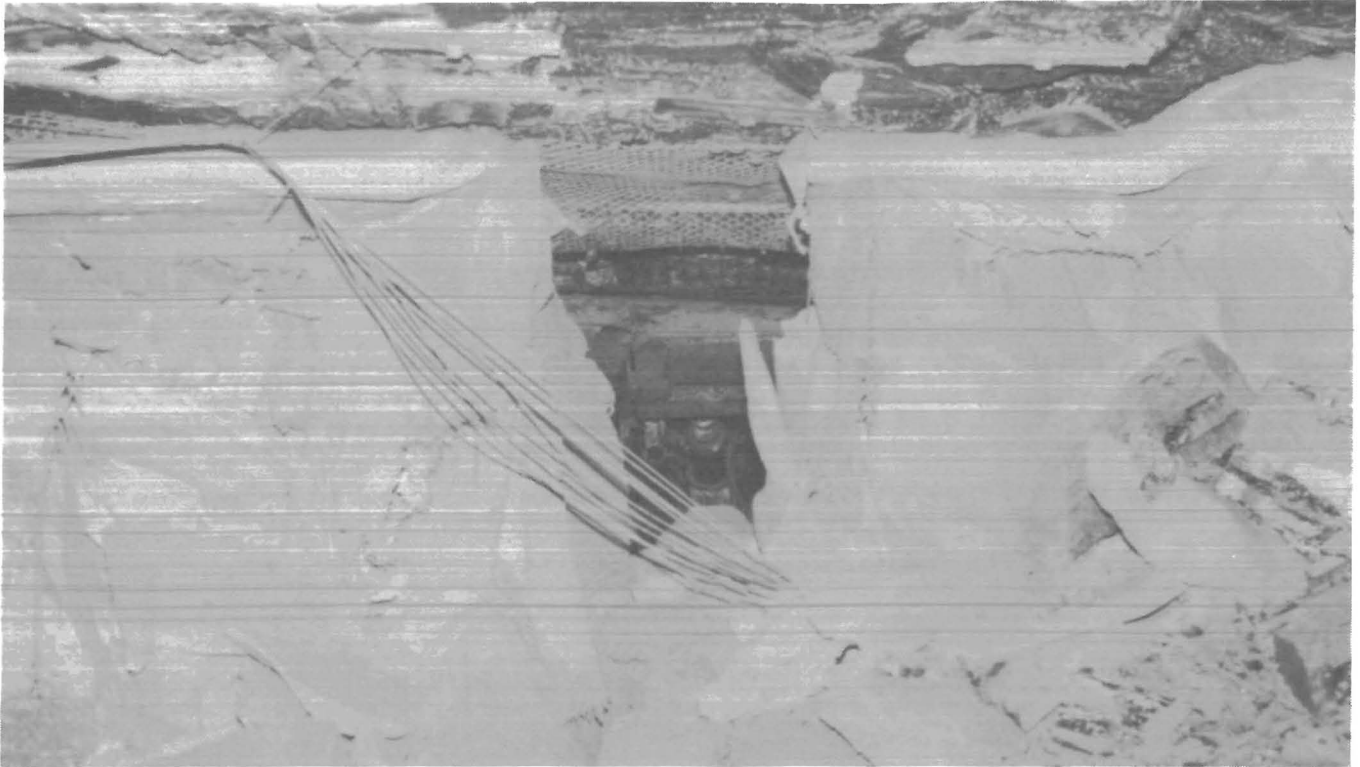
Figure 8.—Example of piers crushed by front abutment in initial recovery room.

As evidenced by the stability of the recovery room, the supports worked as planned. The bolts, channels, and wire mesh enabled the roof to act as a continuous beam while the fly ash-cement piers limited entry convergence. This allowed the front abutment to transfer from the panel to the support pillars without affecting recovery room stability.

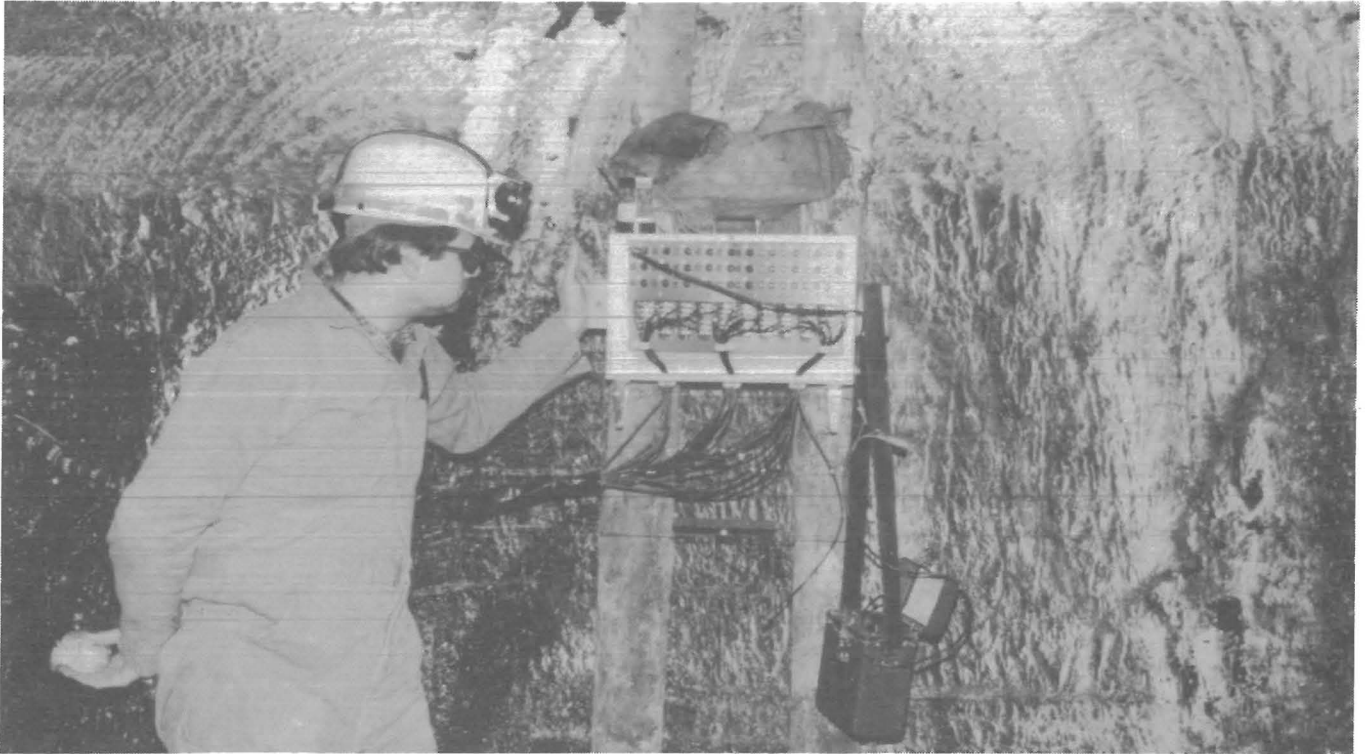
Figure 10.—Centralized readout location.

Vibrating wire stressmeters (VWS) were installed in the longwall panel, piers, and support pillars to measure the front abutment loading. Figure 9 shows the exact locations of the 29 stressmeters installed. The lead wires were strung to a central location for safety and to simplify data collection (fig. 10).

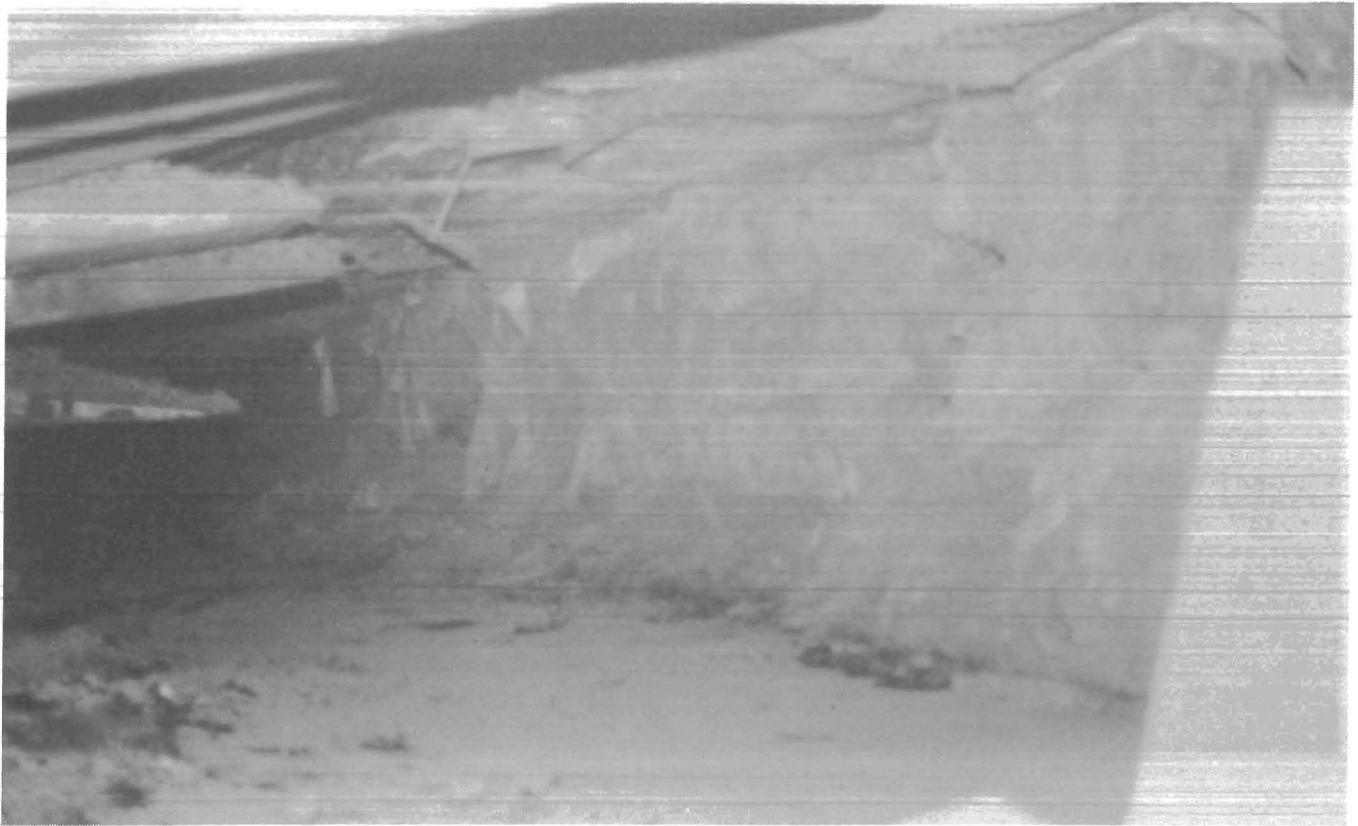
Figure 12.—View of initial recovery room after removal of shearer.

only the extra armored face conveyor was removed; the remaining face continuing to the end of the panel. The shields were old and not deemed recoverable, thus they were left in place (fig. 12).

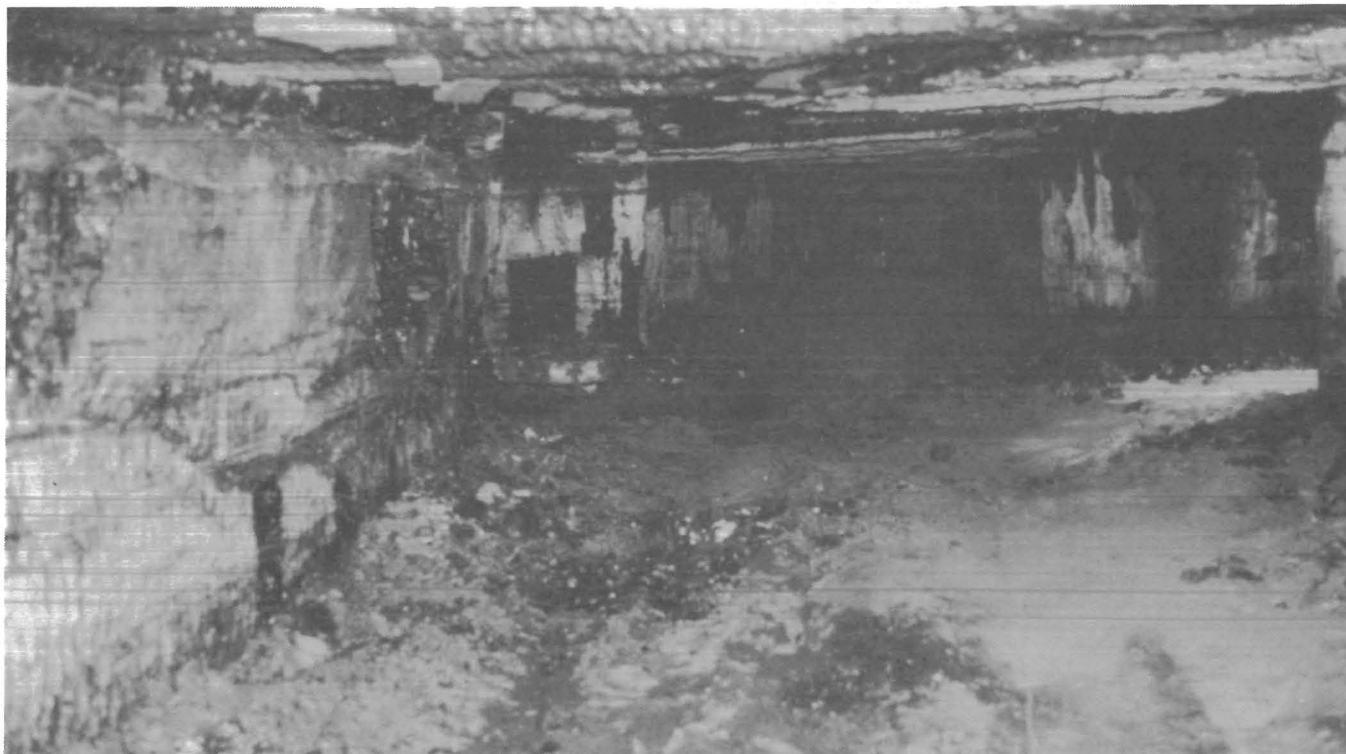
Figure 16.—Typical recovery room prior to supplemental support.

The initial supports in the entry were 6-ft, 3/4-in-diam, full column resin bolts on 4-ft centers (fig. 16). Mine personnel resupported the entry with wire mesh and channels, 12-ft, 1-in-diam, resin super bolts (fig. 17), and cribs constructed of fiber crib blocks (22) and wood fillers (fig. 18). Figure 19 illustrates crib construction and location in the entry. A support resistance of 800 psi was desired in this recovery room also, necessitating erecting nearly 475 cribs in the recovery entry and recovery butts.

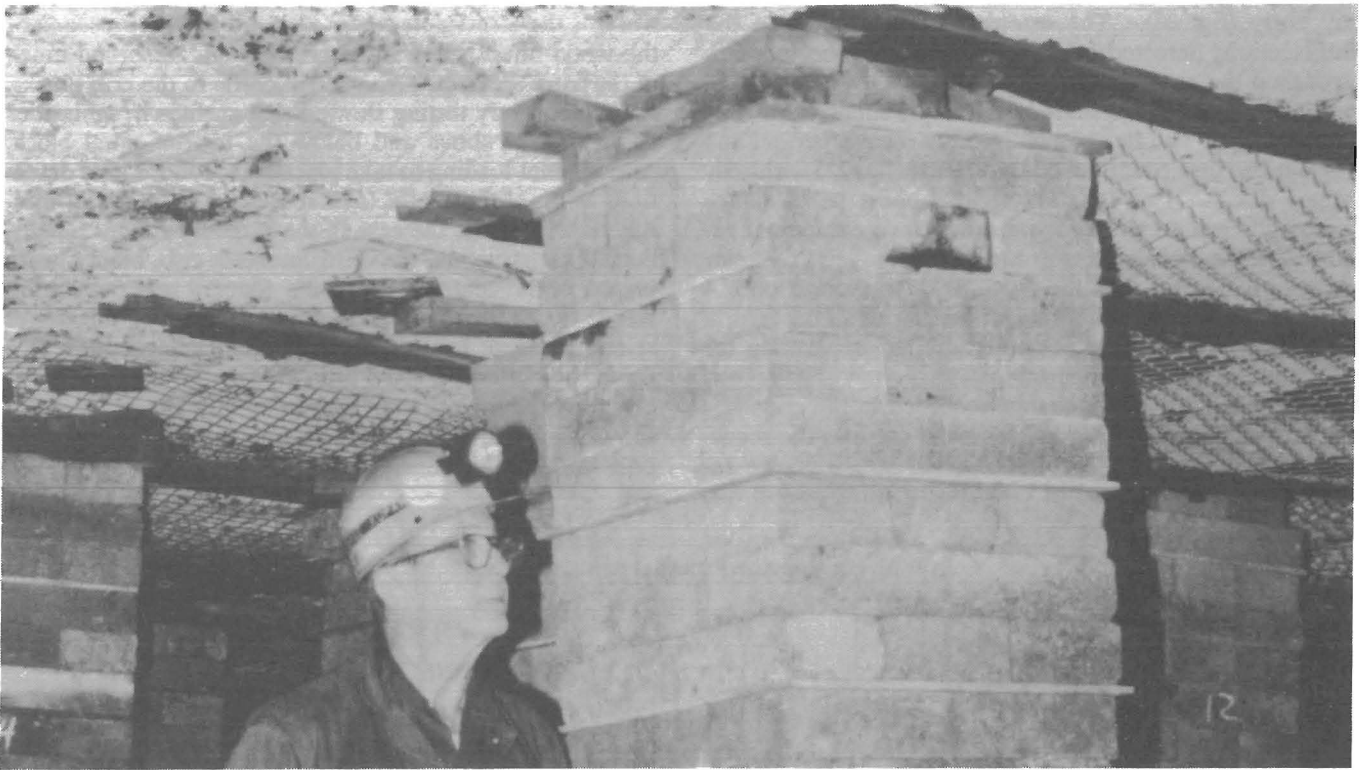
Figure 18.—Installed supports in fullface recovery room.
